Manhole Inspection Summary

Manhole # S47E2_009MH

Insp Date: **1/18/08 10:19 AM**

Location Address: **4110 Plum-Olmstead**

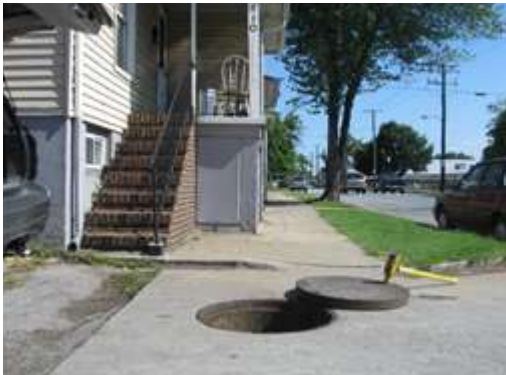
Location View

4110 Plum-Olmstead

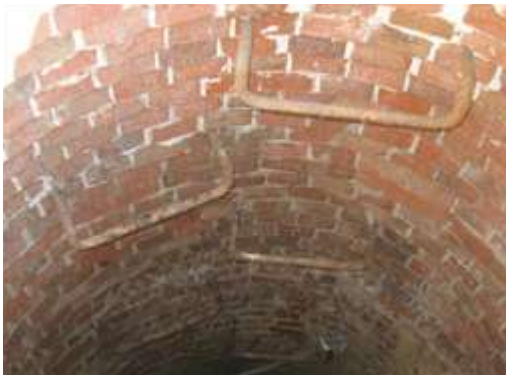
Steps Count: **5** Missing: **0** ☐ Corroded

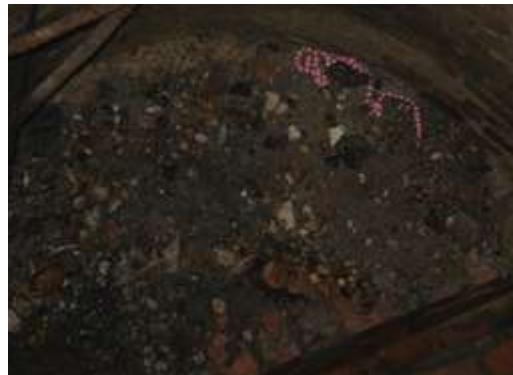
Defect 2

Debris on bench

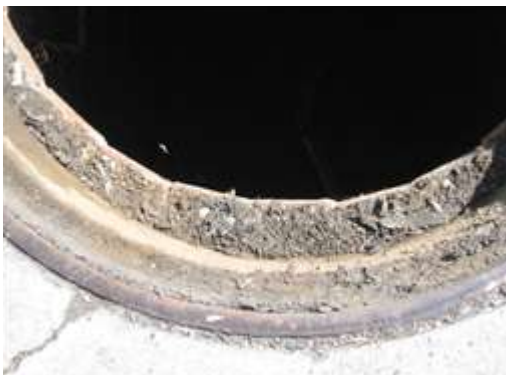
Defect 1

Frame offset

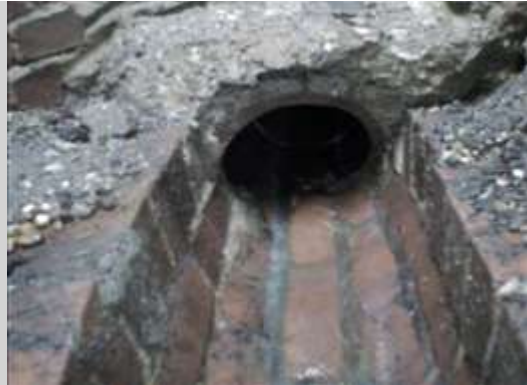
12 O'Clock Outflow

8 in. Circular Gravity Sewer
Pipe Out @ 12 O'Clock

Pipe Height: **8.4** (in.) Rod and Bar (Angled)
Pipe Material: **Clay** ☐ Pipe Lined
Invert Depth: **10.73** (ft.) Flow Characteristics: **Fast**
Deposits: ☒ None ☐ Mud ☐ Sludge ☐ Debris ☐ Grease
Silt Depth: (in.) Deposits Extent:
Infiltration: **None** Pipe Seal Cond: **Sound**

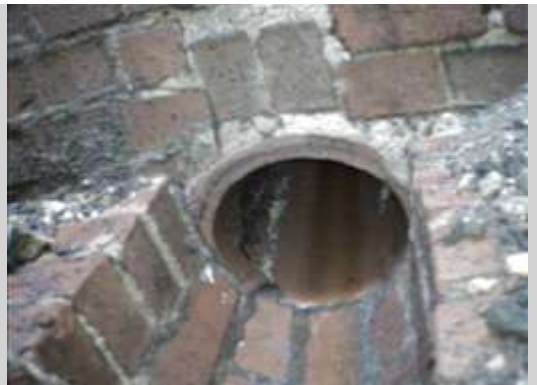
4 O'Clock Inflow

8 in. Circular Gravity Sewer
Pipe In @ 4 O'Clock

Pipe Height: **8.4** (in.) Rod and Bar (Angled)
Pipe Material: **Clay** ☐ Pipe Lined
Invert Depth: **10.13** (ft.) Flow Characteristics: **Fast**
Deposits: ☒ None ☐ Mud ☐ Sludge ☐ Debris ☐ Grease
Silt Depth: (in.) Deposits Extent:
Infiltration: **None** Pipe Seal Cond: **Sound**
